ROYAL
ARMAMENT RESEARCH AND DEVELOPMENT
ESTABLISHMENT

R.A.R.D.E. MEMORANDUM 8/67

Bore pitting in 81mm mortar barrels

J. Morris

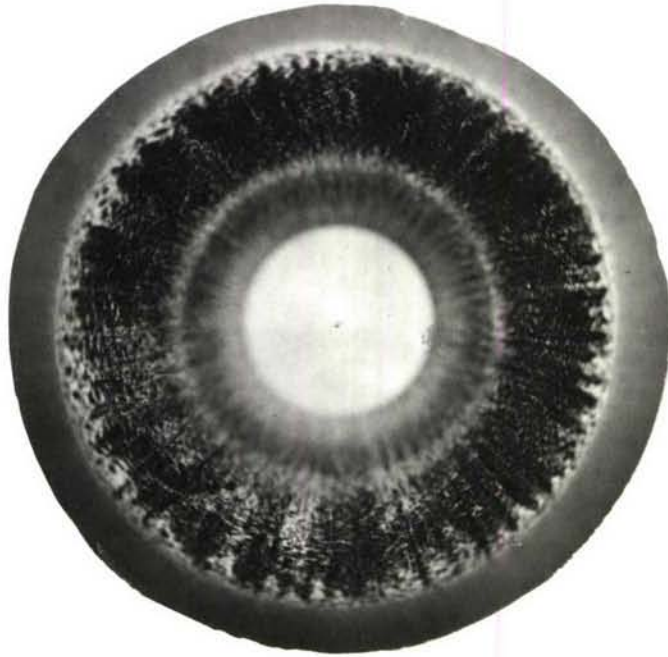
*FIG.6. Barrel L/112. Ex M.E.L.F. Fired 1228 bombs
obturated P.V.C. rings. Breech end view.*

of the contact side of a plastic impression of the internal surface of L/114 by X-ray fluorescence showed chlorine to be present, (contact side - 474 counts/sec., reverse side - 56 counts/sec.). Photographs were taken from outside the barrels with a studio camera aligned on the longitudinal axis from the Breech ends, Figure 6 showing barrel L/112 is representative of these.

Three of the six barrels were returned to the U.K., Their firing histories were - L/566 fired 702 rounds, L/580 fired 459 rounds and L/707 fired 608 rounds. Visual inspection showed L/566 and L/580 to be very clean and almost free from bore imperfections. L/707 had a very faint dendritic pattern on the bore near shot start with sporadic incipient pitting in this region. Impressions taken on the bores and measured in the same manner as those from the previous six (P.V.C.) barrels showed no unusual bore contours. Figure 7, shows a breech end view of the bore of L/707 for comparison with that of L/112 (Fig. 6).

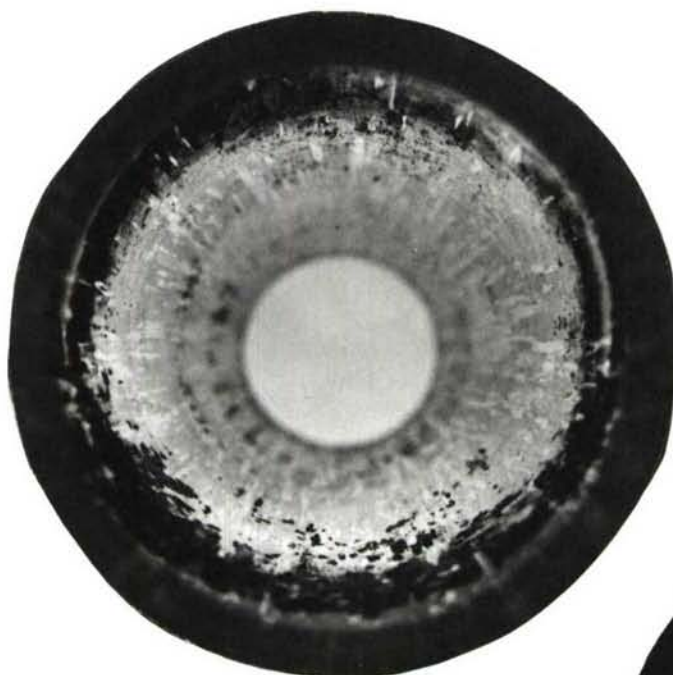
FIG. 8. Barrel L/521.
R.A.R.D.E trial, fired 184 bombs
obturated with Polycarbonate rings.
Breech end view.

3.3.1 The barrels were left in the "as cleaned" condition on completion of the trial. On receipt in R.A.R.D.E/D2, twelve days after the last cleaning, it was observed that there had been a very slight increase in the area of the black deposits in the bores of the barrels that fired unobtured and P.C. obtured bombs. (L/539 and L/521) In contrast there had been considerable build up of deposits on the bore of the barrel which fired P.V.C. obtured bombs. There were heavy black deposits throughout the full area of shot travel with streaks of rust, in appearance the barrel bore was dirtier than it was in the "as fired" condition. Figures 8, 9 and 10 show the appearance of the bores on receipt in R.A.R.D.E. Barrel L/530 (fired P.V.C.) was given a light brush-through before photographing to aid definition - Figure 10.

3.2.2 Subsequently the barrels were passed to D.3 Branch for chemical examination. After samples had been taken from the bores the barrels were cleaned. L/521 (P.C.) showed no etching or pitting effects, L/539 (unobtured) showed very slight traces of etching, in areas where some rusting had occurred, and
